STRESS CORROSION CRACKING OF ROCK BOLTS

Erwin Gamboa

A THESIS SUBMITTED TO THE UNIVERSITY OF QUEENSLAND
FOR THE DEGREE OF DOCTOR OF PHILOSOPHY

NOVEMBER 2004

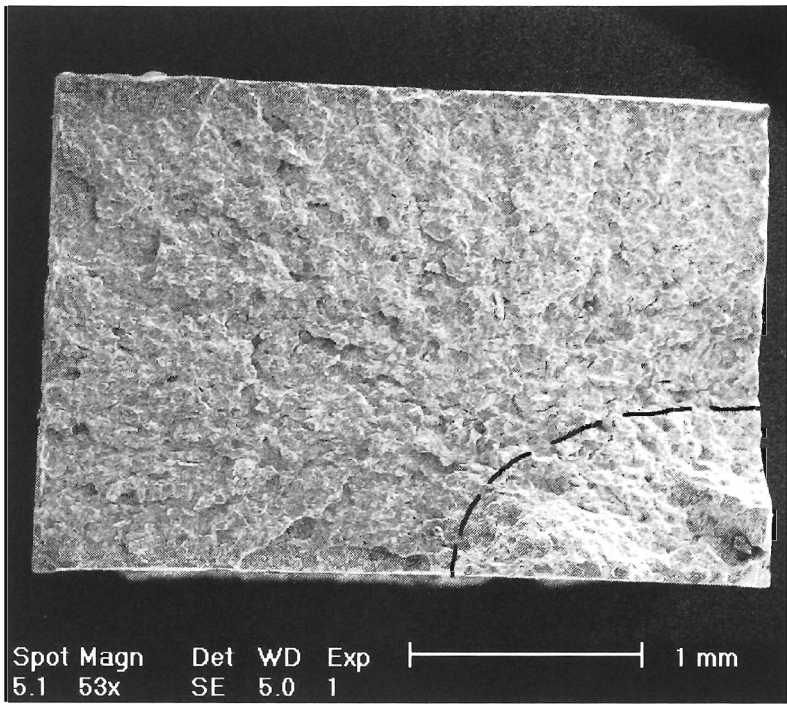
FIGURE 8.2: Overview of LIST 24

Anderson [61] provides a better estimate to K_{Ic} that takes into account the quarter elliptical crack shape. This provides an approximation of the geometry factor Y . Figure 8.1 presents the geometry considerations. Samples LIST 24 (Figure 8.2) and LIST 41 (Figure 8.3) gave the values listed in Table 8.1.

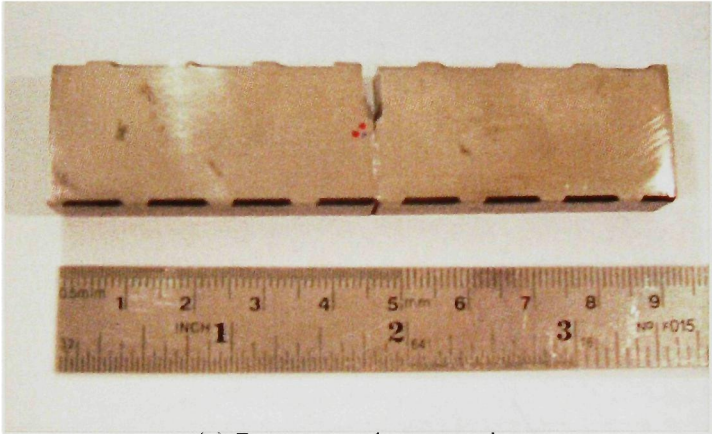
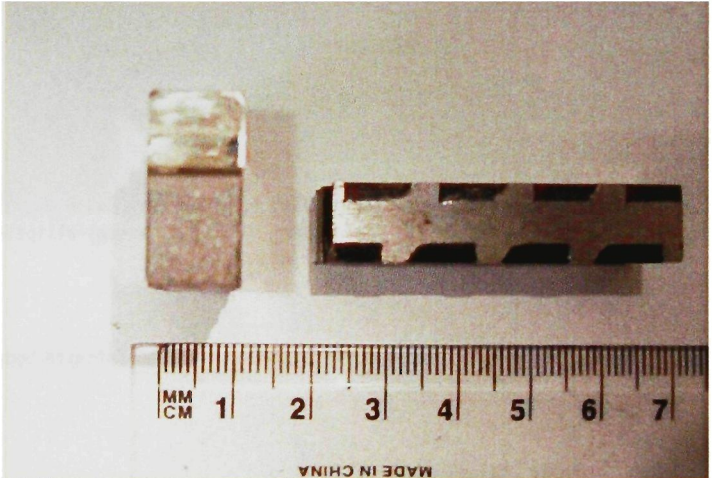
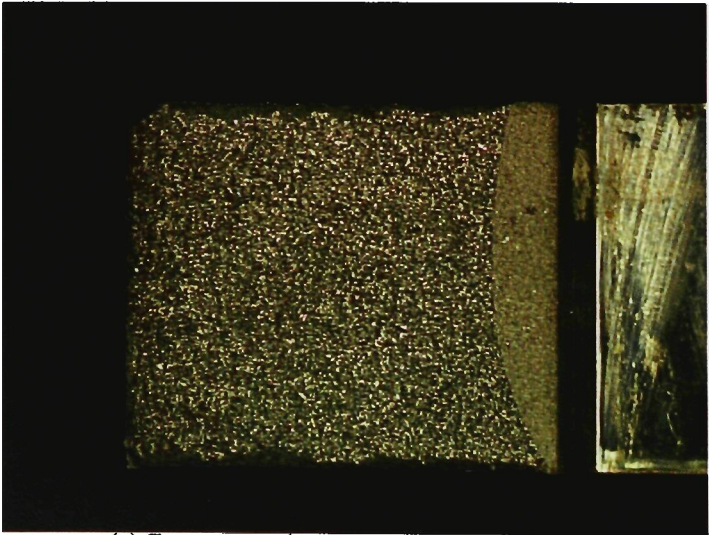
FIGURE 8.5: Fracture toughness sample

Figure 8.5(a) shows the fractured sample reassembled as it looked like before failure. After fracture, it was observed that the fatigue crack front had not grown in an even manner in either of the samples. Figure 8.5(b) shows the shiny brittle fracture surface on the left and the bolt rib pattern on the right. Figure 8.5(c) shows a higher magnification of the fracture surface. The uneven fatigue pre crack can be seen on the surface, being thinner on the bottom than on the top. This was attributed to the samples rocking sideways while the load applied was fluctuating. This small rocking motion was attributed to the remaining bolt rib pattern causing the load to be distributed unevenly.

(a) Fracture toughness sample

(b) Fracture toughness sample showing fracture surface and rib pattern

(c) Fracture toughness sample fracture surface

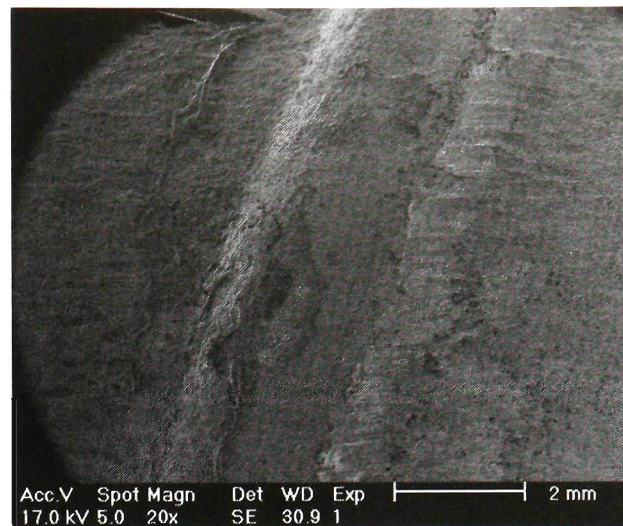
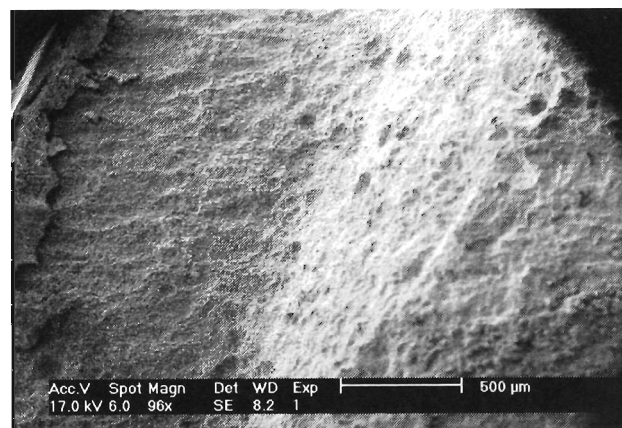
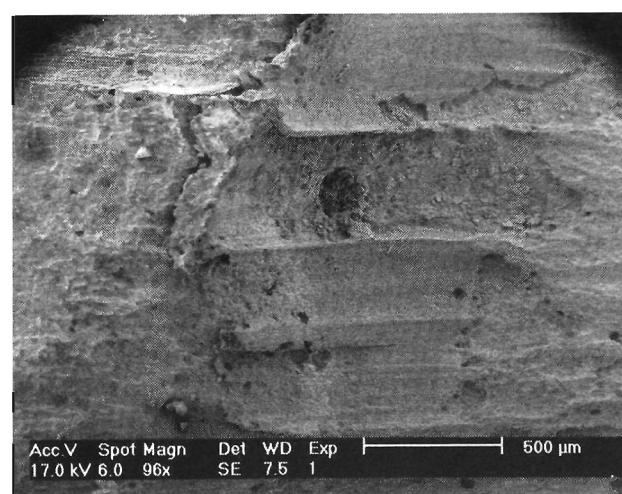
FIGURE 9.1: Typical rock bolt rib for an AXR rock bolt

Figure 9.1 shows a typical overview of a geometry sample after being immersed in the sulphate pH 2.1 solution for a time at a stress close to the threshold stress. Figure 9.1(a) shows an overview, with the rib running vertically, with the smooth side (larger radius of curvature) on the right. Figure 9.1(b) shows a higher magnification view of the sharp foot of the rib. Figure 9.1(c) shows a higher magnification view of the smoother side of the rib. The Figures show that the smoother side of the rib displays greater corrosion damage. Any of the multiple pits seen can be an initiation site for a stress corrosion crack if the stress goes above the threshold stress.

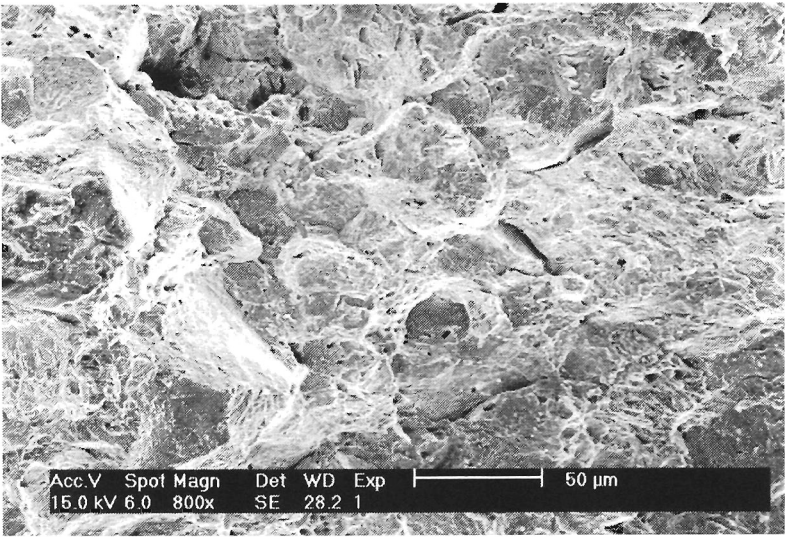
One sample was tested that had a side rib (LIST 101). That sample cracked at 108.5 hours at a stress of 533 MPa. Figure 9.2 shows CIS fracture surface on that sample.

FIGURE 9.2: CIS on a 1355AXRC geometry sample

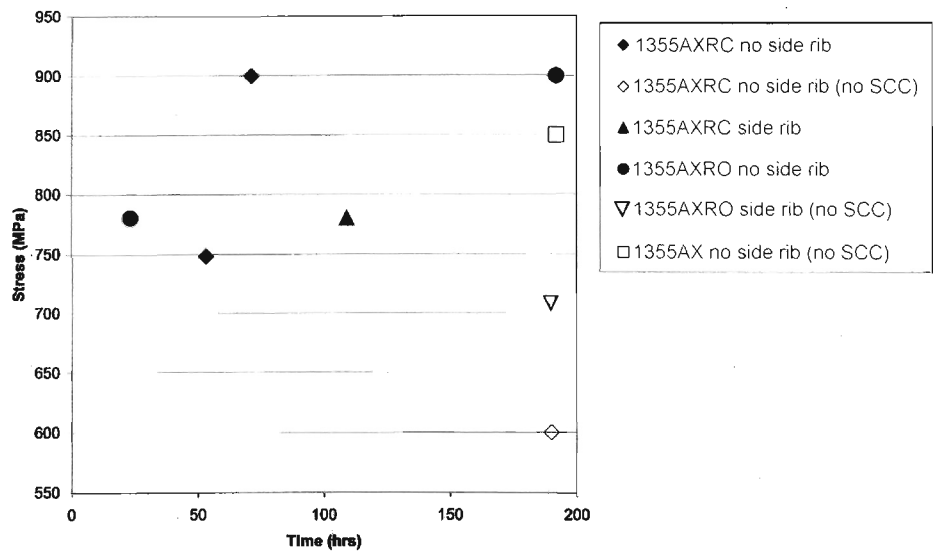
Figure 9.3 shows a plot of applied stress versus time to failure for the various rock bolts. A full symbol represents a sample failing due to SCC. An empty symbol represents a sample that did not fail by SCC after being held at the determined stress after 192 hours.

The results in Figure 9.3 show that 1355AXRC bolts can fail when stressed at around 750 MPa. This smaller value than the established threshold stress of 900 MPa for the 1355AXRC suggests that there could have been a residual stress in the rib pattern helping to initiate SCC at a lower applied stress. The magnitude of the residual stress is suggested to be between 150 MPa and 300 MPa, as a sample of the same metallurgy did not fail by SCC after 192 hours at a direct applied stress of 600 MPa.

The sample with the smallest rib profile (1355AX) suggests that it does not have a residual stress greater than 50 MPa, as the sample did not fail by SCC at a direct applied stress of 850 MPa.

FIGURE 9.3: Applied stress vs time to failure for different rock bolts

The process by which the ribs are introduced in the bolt can have a negative impact on its SCC properties. If bolt ribs are introduced by rolling, residual tensile stresses remain, lowering the direct stress that they are able to sustain before SCC initiates. On the other hand, cold work may increase the resistance to SCC by introducing dislocations able to trap hydrogen (Chapter 8). Further study is recommended to study the optimum levels of cold/hot rolling of the ribs for SCC resistance.
